Purification of refuse pond (automotive painting line)

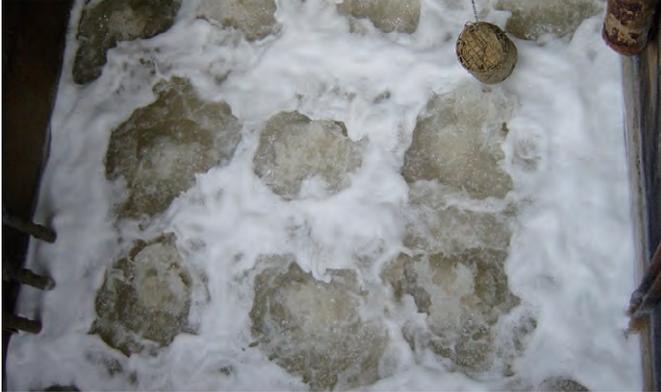
- Circulating water type : Circulating water for painting
- Water tank : 50m³
- Model : Aquablaster system

Fourteen Aquablaster AS-250 (previous model) units were installed in a 50-ton water tank.

The service life of circulating water, which could previously be used for only one month, was lengthened to three months, and putrid odors were virtually eliminated.

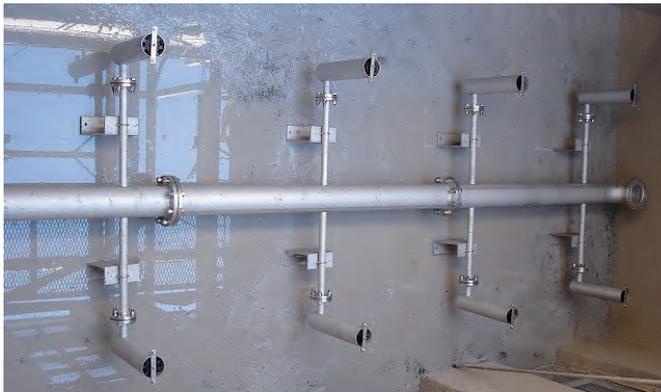
- Circulating water type : Circulating water for painting
- Water tank : 280m³
- Model : Aquablaster system

In four 70-ton water tanks, totaling 280-tons, ten Aquablaster units were installed in Tank no. 2 and five units in Tank no.3.

Putrid odors were virtually eliminated and the service life of circulating water, which could previously be used for only one month, was lengthened to five months. Even so, the load on final-stage wastewater treatment equipment was lightened.

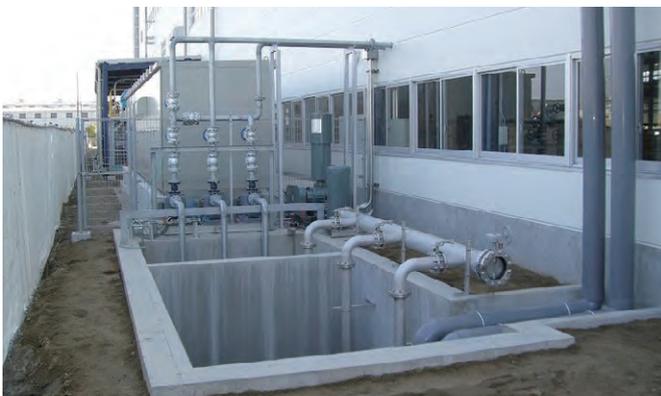
- Circulating water type : Circulating water for painting
- Water tank : 30m³
- Model : Aquablaster system

Three new 10-ton circulating pits (refuse ponds) were constructed, and four Aquablaster units were installed in each one.

Operation continued for 14 months with absolutely no need for maintenance, cutting annual costs by almost ¥50 million.
